INSTRUCTION SHEET FOR #2456-1

POWER GLIDE TAPPET

BIG TWIN - FITS 1984-PRESENT

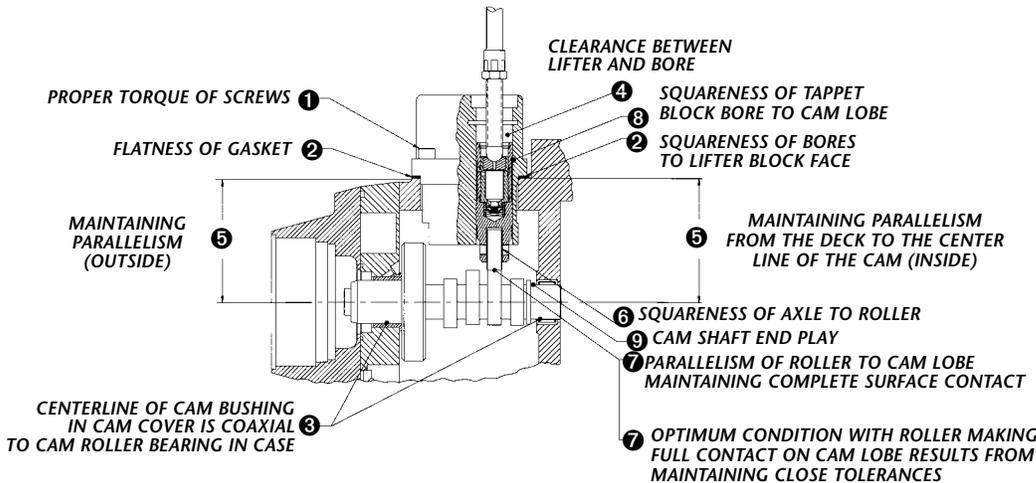
PUSHROD ADJUSTMENTS				
Distance per turn	Distance per flat	Threads per inch	Wrench Flats	Total Travel Distance
.0417	.0069	24	15	.1042"
.0357	.0059	28	17	.1011"
.0313	.0052	32	18	.0937"
.025	.0042	40	24	.100"
.0192	.0032	52	30	.0962"

6. Extend the pushrod adjuster 15 wrench flats if pushrods have 24 threads per inch, 17 wrench flats if pushrods have 28 threads, 18 wrench flats if your push rods have 32 threads per inch, 24 wrench flats if your push rods have 40 threads per inch and 30 wrench flats if your pushrod has 52 threads per inch. Tighten lock nut. Note: Popular Pushrod adjustments on back of page.
IMPORTANT NOTE: This adjustment will make the pushrod tight, which will bleed the hydraulic lifter. It can take 10-15 minutes, or longer, to bleed off. It is very important that the engine is not rotated while pushrods are tight. The pushrod will spin with your fingers after the tappet has bled off.
